**ON A GEOLOGICAL SURVEY
OF "VISOČICA" ELEVATION
IN VISOKO, BOSNIA AND HERZEGOVINA**

By Nadjija Nukic, Geologist

Sarajevo, November 2005

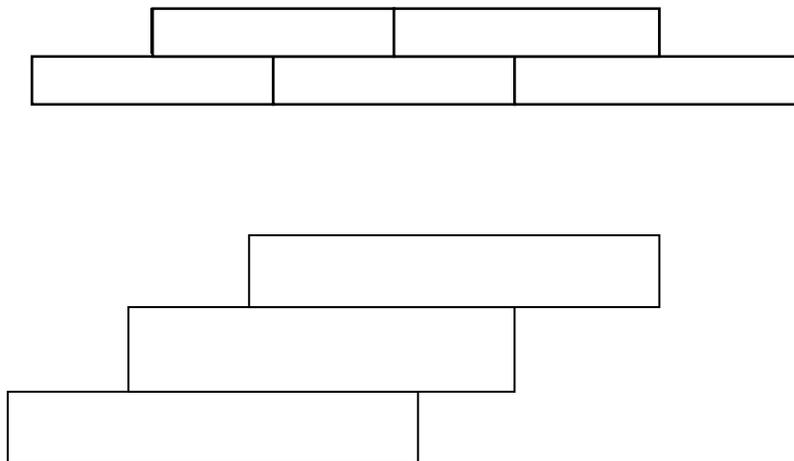
An excavation done by mattock and shovel already revealed certain rough outline with specific geometry. When the blocks were cleaned by a broad knife and small broom it was found that they were ordered like bricks in a brick wall – the upper block was moved inwards in relation to the lower one.

The edges between the blocks are not clearly visible as flat surfaces because, as I stated before, breccia cracks and falls apart when exposed to frost. As the layer of humus is not very powerful, it could not protect the surface layer of breccia. It is interesting, though, that the blocks which were covered with moss are complete and undamaged.

Two such blocks were discovered under this probing well. The flat sides of these blocks and the connection line between them are clearly visible.

Further detailed cleaning of the connection line between the two blocks, at the specific area where humus grew deeper, revealed that the block was manually processed underneath and that its surface was flat and smooth.

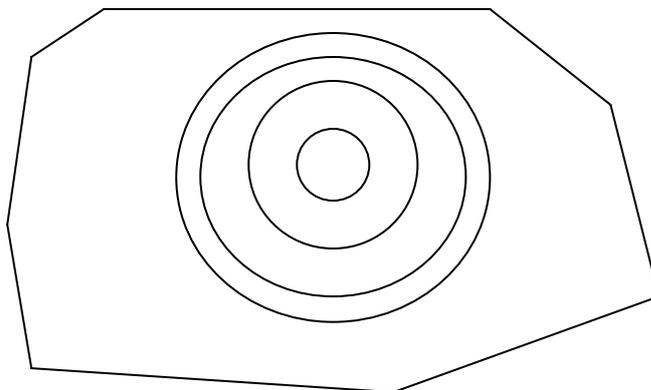
A sandstone plate with clearly visible concentric circles was found at the depth of 0.70 metres. This feature should be investigated further in a research process in order to determine whether the circles were made manually.
